# NDT OF COMPOSITES @ UGENT-MMS

Prof. dr. ir. Mathias KERSEMANS

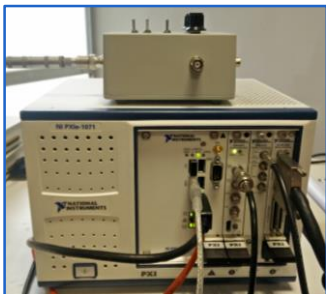
PXIe

## In-house developed ultrasonic scan inspection facilities

- 3-, 5- and 6-axis scanners
- Fully programmable → complete freedom in scan strategies
- Various ultrasound regimes available
  - Conventional liquid-coupled ultrasound
  - **Phased array** ultrasound
  - Ultrasonic **microscopy** (up to 100 MHz)
  - **Air-coupled** ultrasound

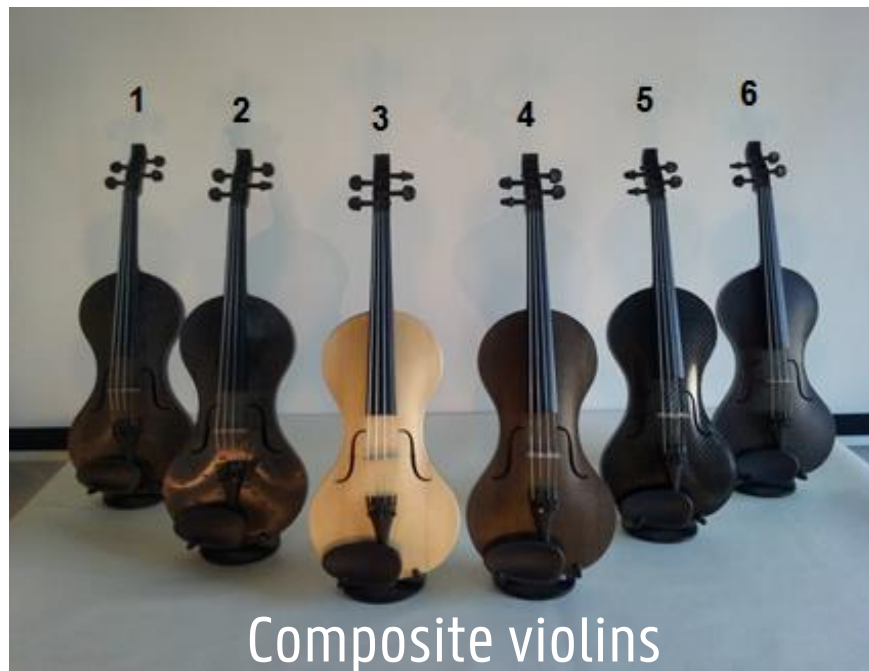
## Modal analysis

- ✓ Measure the vibrational response
- ✓ See the vibrational patterns

$f = 1037 \text{ Hz}$

$f = 963 \text{ Hz}$

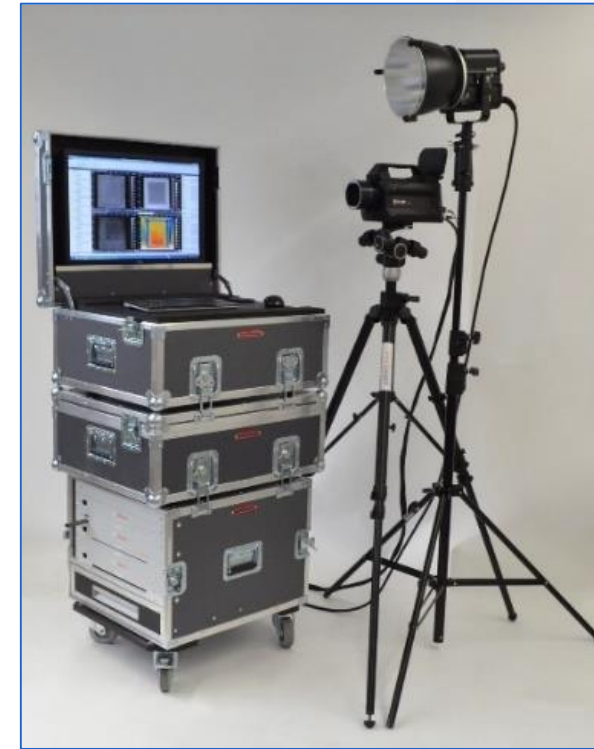
IR THERMOGRAPHIC SYSTEM

## Advanced infrared thermographic system

- Cooled infrared camera FLIR A6750sc
- Pixel density =  $640 \times 512 \rightarrow$  full field technique
- NETD < 15 mK
- High-standard control module
- Various thermography regimes

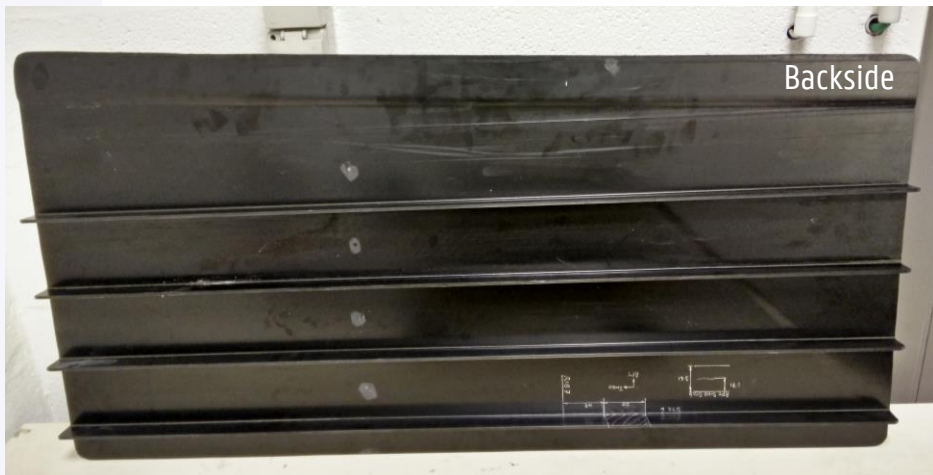
## Airbus A400M stiffened flap panel
